## DOCUMENTATION OF ENVIRONMENTAL INDICATOR DETERMINATION

Environmental Indicator (EI) RCRIS code (CA750)

### Migration of Contaminated Groundwater Under Control

Facility Name: Kimberly-Clark PA, LLC

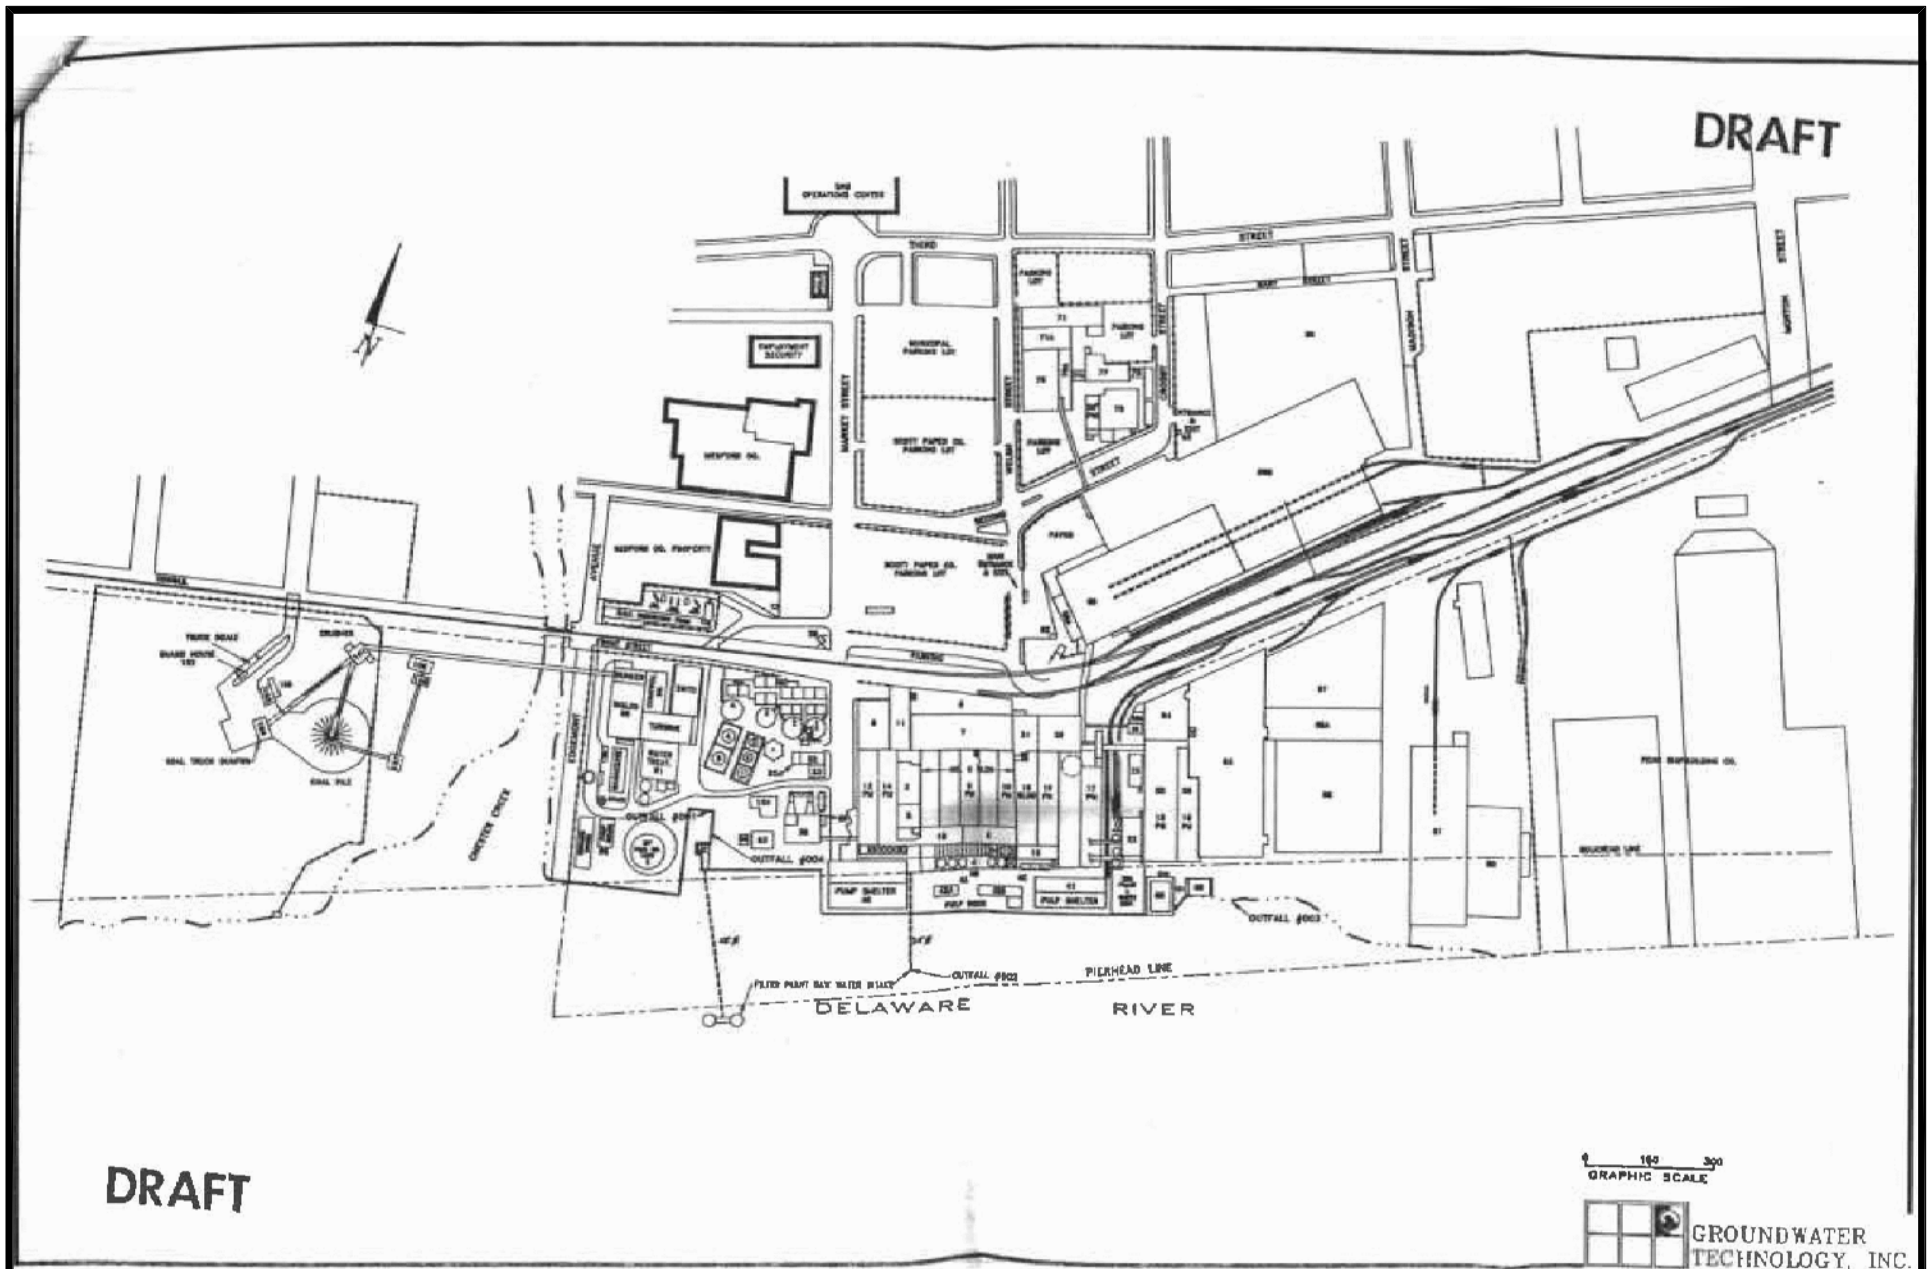
FIGURE 2: FACILITY LAYOUT  
KIMBERLY-CLARK PA, LLC  
FRONT STREET AND AVENUE OF THE STATES  
CHESTER, PENNSYLVANIA 19013

On November 14, 1980, the facility submitted a Part A Hazardous Waste Permit Application for storage of hazardous wastes in containers inside of Building 81 (Appendix B: Figure 2 - Facility Layout Map). Thirty-two (32) waste codes were listed in the application. However, the facility indicated that 28 of the listed waste codes were actually raw materials used by the facility in the manufacturing process. The raw materials were listed as wastes in the event the materials would become wastes due to circumstances beyond the facility's control. The remaining four waste codes (USEPA Hazardous Waste Code F001, F002, F003, and F004 – spent halogenated and non-halogenated solvents) were actual wastes generated by the facility. USEPA acknowledged receipt of the Part A Hazardous Waste Permit Application on December 22, 1980 and again on July 27, 1981.

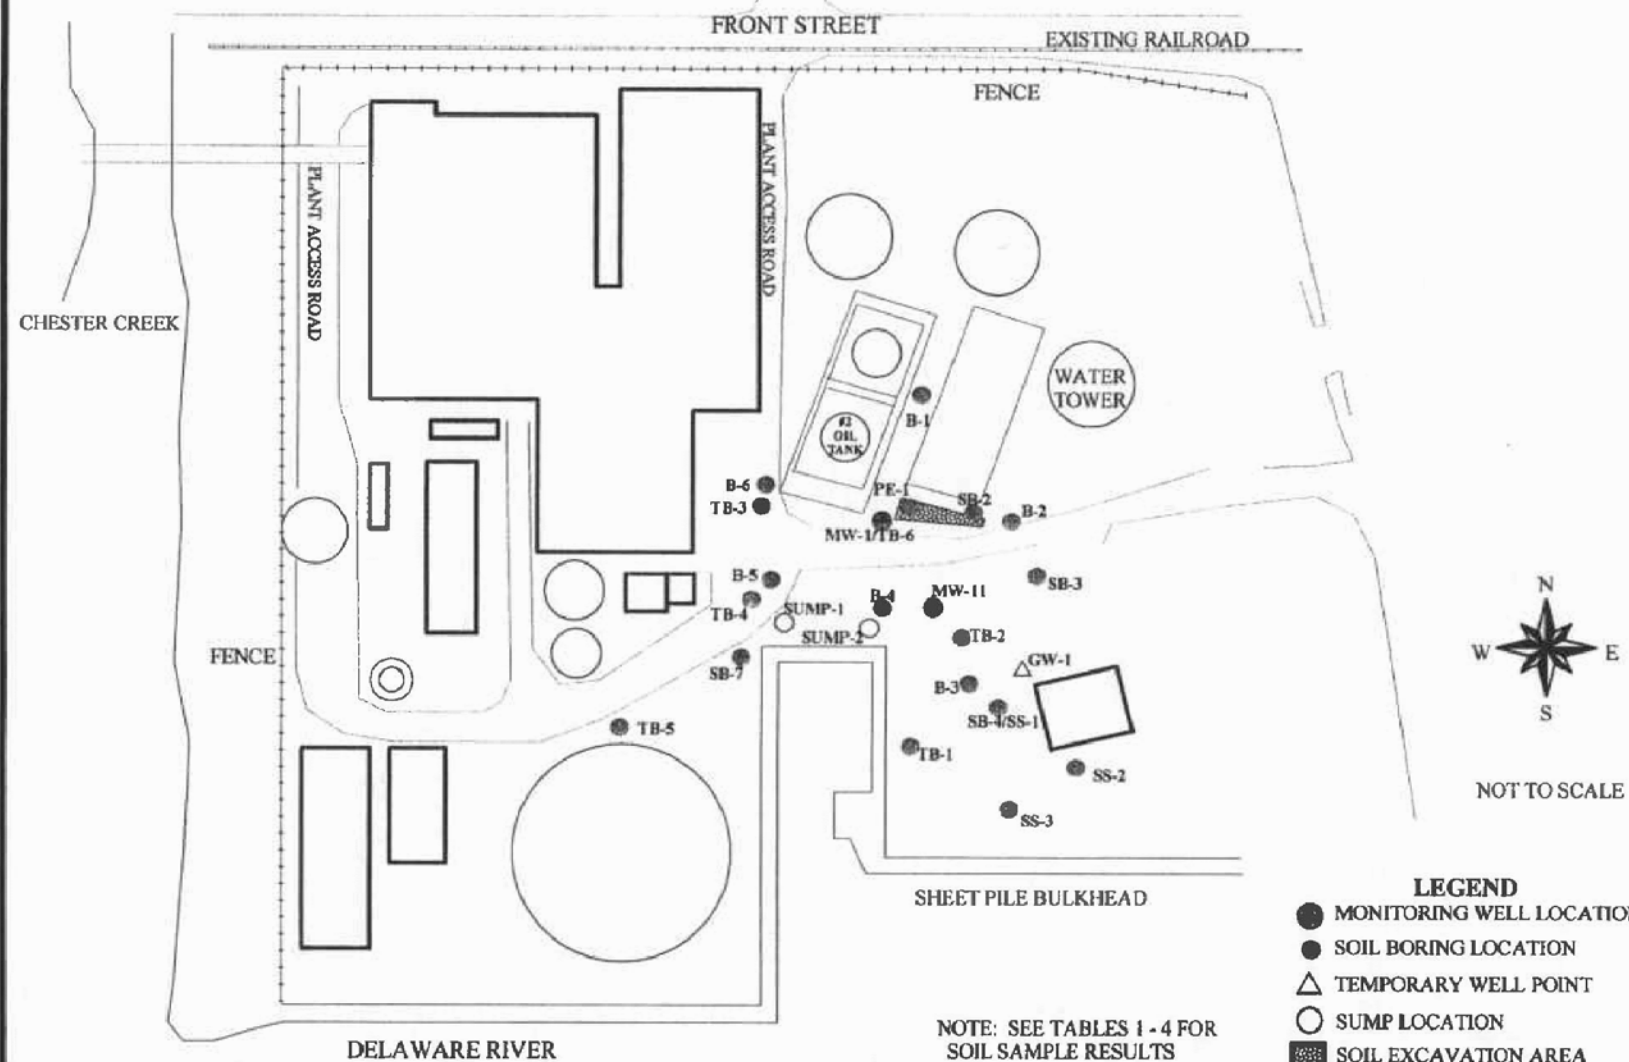
FIGURE 3: SOIL SAMPLE LOCATIONS  
KIMBERLY-CLARK PA, LLC  
FRONT STREET AND AVENUE OF THE STATES  
CHESTER, PENNSYLVANIA 19013

response activities. On October 3, 1989, Triegel initiated a subsurface soil and groundwater investigation in the No. 2 Fuel Oil Area at the request of the facility (Appendix B: Figure 3 - Soil Sample Locations). The investigation included drilling and sampling of six soil borings (TB-1 through TB-6) and installation of one groundwater monitoring well located immediately downgradient from the release. The soil borings ranged in depth from 10 to 16 feet bgs. The samples were collected from depths ranging between six and 12 feet bgs. The nature of the soil was loose fill (clayey silt with rock, brick, and coal fragments situated above natural dark gray silt; a soil layer that is naturally high in organic content and was referred to in the Triegel report as “meadow mat”).

In addition, Smith collected six soil samples, two of which were collected from the monitoring well boreholes (SB-1 through SB-5, and SB-7, Appendix B: Figure 3 - Soil Sample Locations). The soil samples were analyzed for diesel range organics (DRO) and BTEX. (Note: The tabulated data presented in the Final Report [Atlantic, 2000] indicates the soil samples were analyzed for BTEX and TPH.) TPH concentrations in the soil samples ranged from 306 mg/kg to 12,000 mg/kg. The highest TPH concentrations were detected at SB-4 (12,000 mg/kg), SB-5/MW-11 (5,160 mg/kg), SB-7 (2,460 mg/kg), and SB-1/MW-1 (1,240 mg/kg). BTEX concentrations were less than the laboratory detection limit or where measurable, were less than the PADEP direct contact and soil to groundwater used aquifer non-residential MSCs as described by Atlantic in the Final Report (2000).

In December 1997, an exploratory test pit was dug near MW-1, where petroleum impacted soils were encountered at three feet bgs (Appendix B: Figure 3 - Soil Sample Locations). Approximately 10 cubic yards of contaminated soil was removed during the excavation and transported offsite for recycling. Soils in the north, east, and west sides of the excavated area did not appear to be impacted. The south side of the excavation was bound by a concrete foundation wall that extended to the water table, which was believed to have limited the migration of SPL beyond the vicinity of MW-1. Soils between MW-1 and the No. 2 fuel oil AST containment wall (west side of the excavation as shown on Figure 3) could not be excavated due to the presence of the overhead pipe rack and the containment wall. One post-excavation soil sample (PE-1) was collected near MW-1 and was analyzed for polynuclear aromatic hydrocarbons (PAHs). Benzo(a)anthracene (0.63 mg/kg), benzo(a)pyrene (0.58 mg/kg), and phenanthrene (0.7 mg/kg) were detected in the sample. According to the Final Report (Atlantic, 2000), the concentrations of the detected PAHs were below the PADEP direct contact and soil to groundwater used aquifer non-residential MSCs. TPH were also detected in sample PE-1 at 13 mg/kg.

In January 1998, Roux drilled three additional soil borings (identified as SS-1, SS-2, and SS-3) (Appendix B: Figure 3 - Soil Sample Locations) east of the barge slip in the vicinity of the highest historical TPH concentrations (boring SB-4 drilled by Smith in 1995). One soil sample was collected from each boring approximately six inches above the water table. Each soil sample was analyzed for naphthalene, fluorene, benzo(a)anthracene, benzo(a)pyrene, and phenanthrene.
